# CONNECT-EZ LOAD TEST REPORT

## Phase I

Series "V" - 12 x 12

**University of Cincinnati**

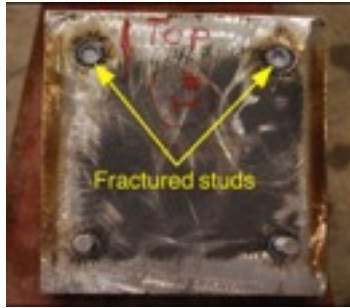
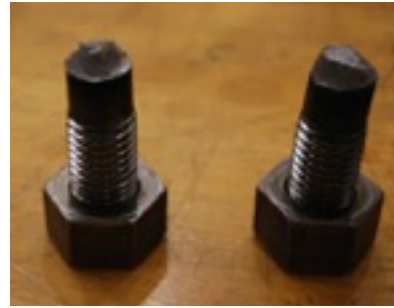
Figure 4 Failure Mode

In this specimen, the back edge of the seat was welded (1/4 inch x 5 inch fillet) to the inside face of the chamber. The measured loads are summarized in Table 3. The specimen failed at 70 kips. The failure was due to fracture of the top two studs, as shown in Figure 4. The failure load corresponds to a factor of safety of 2.33.

The failure modes were generally ductile with the exception of stud fracture in CV-EZ “V” 12x12x0.5 device. Nevertheless, the studs fractured at a load 233% larger than the working load, and it occurred after excessive bending in the seat angle. In this case, the observed stud fracture may be classified as “ductile” because of excessive visual deformations prior to failure.

The studs in specimen C-EZ "V" 12x12x0.50 – Seat Welded fractured. The stud capacity was computed based on the following assumptions: (a) the lateral load is distributed equally among the studs, and (b) the studs on the compression face of the connection resist 75% of the shear due to gravity load. Various parameters and the computed capacities are shown in Table A.1. By ignoring the strength reduction factors, which is reasonable when evaluating test specimens with known properties and dimensions, the gravity load corresponding to the expected stud capacity is 71 kips. This value is nearly identical to 70 kips at which the studs in this specimen fractured.

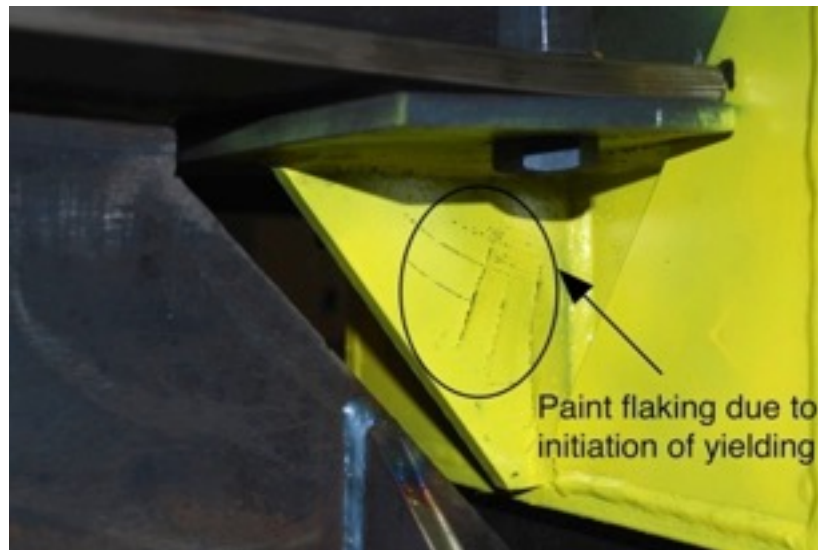
**Figure 5 Initiation of Yielding**

In this specimen, the back edge of the seat was welded (1/4 inch x 6 inch fillet) to the inside face of the chamber. The test results are summarized in Table 4. After applying 76 kips of gravity load, the gusset plate under the seat began to yield, as shown in Figure 5. At 97.2 kips, the weld between the seat and the chamber began to fracture after noticeable bending of the seat (see Figure 6), and testing was stopped. After weld fracture, the connection was still able to resist 63.5 kips of gravity load, which corresponds to a safety factor of 2.12, and 2.3 kips of lateral load. Considering the excessive bending of the seat and residual capacity, the failure mode is classified as ductile. The failure load corresponds to a safety factor of 3.24.

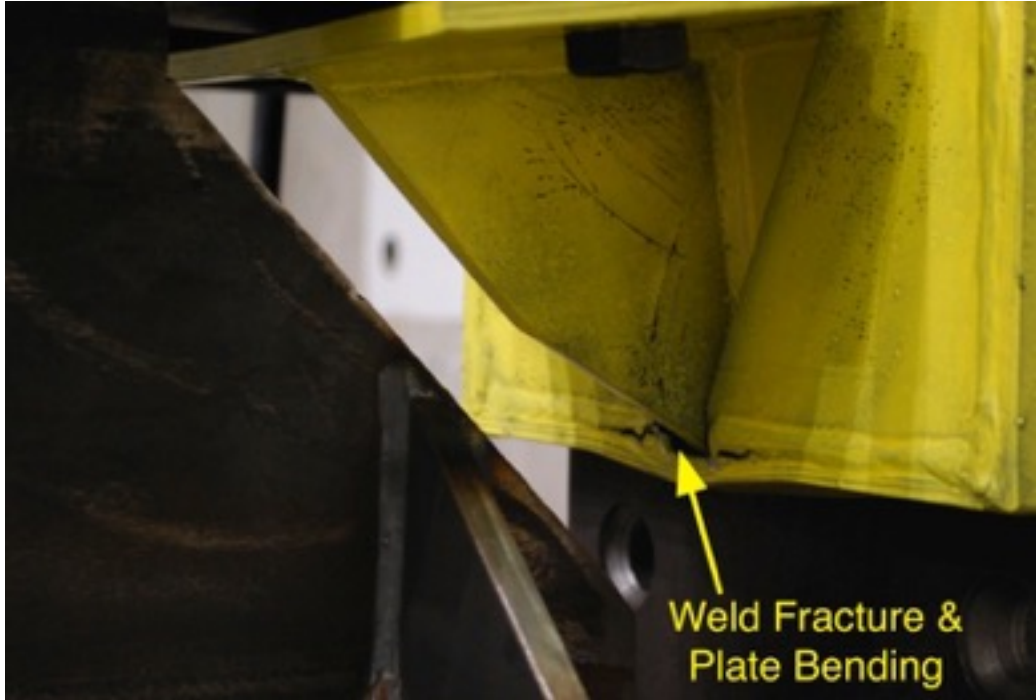
**Figure 7 Failure Pattern at Peak Load**

The seat was not welded in this specimen. As a result, uplift loads were not applied. The test results are summarized in Table 5. After developing 67.4 kips of gravity load (which corresponds to a safety factor of 2.25), the chamber's bottom plate directly below the seat began to fail, as seen from Figure 7. The failure mode was ductile, and was due to weld fracture accompanied by plate bending. The gusset plate had begun to yield as evident by paint flaking.

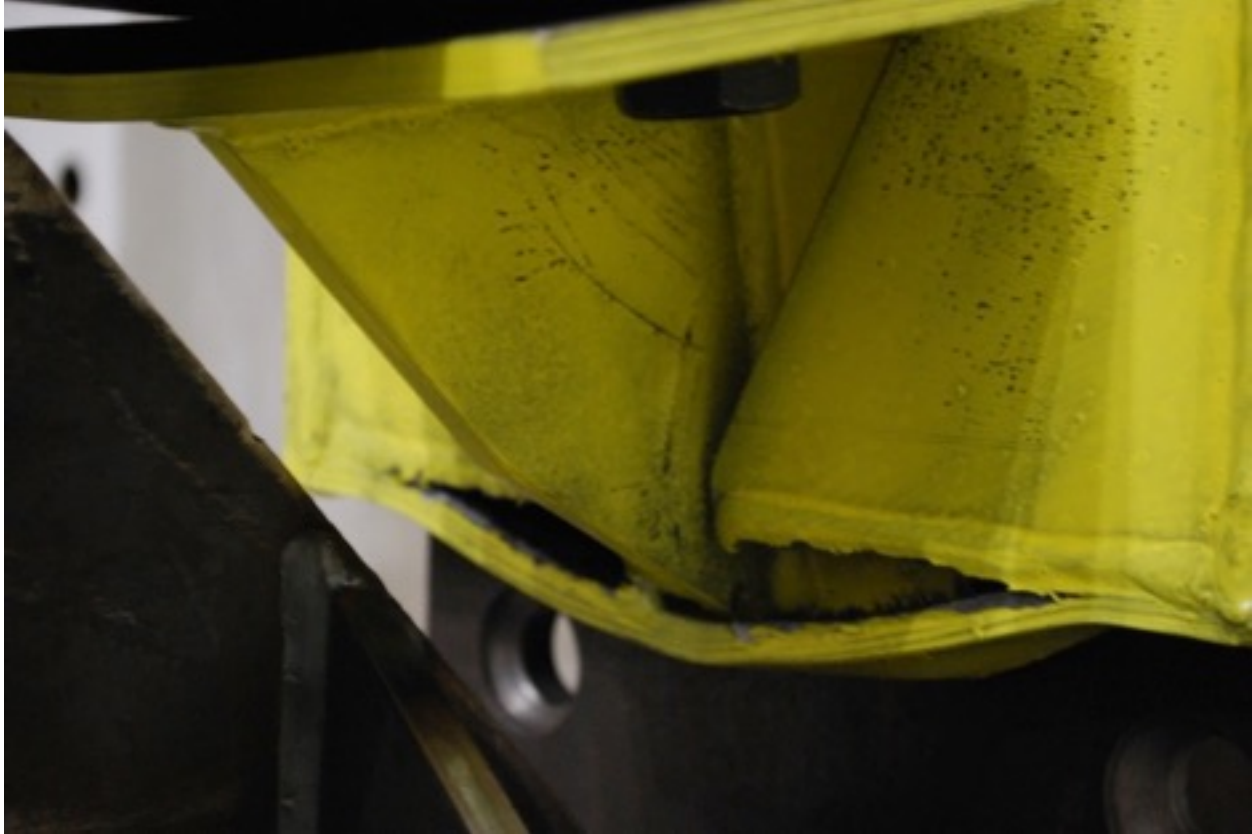
**Figure 8 Condition of the Connection at the Conclusion of Testing**

Beyond the initial weld fracture and plate bending, the connection was able to resist additional loads. It was able to resist 5.5 kips of lateral load and 49.5 kips of gravity, both of which exceed the service level loads of 4 kips and 30 kips, respectively. Due to excessive deflection of the loading beam, the lateral load was removed and the gravity load was increased to 54.5 kips. At this load the weld fracture and plate bending had spread over a large portion of the chamber, refer to Figure 8, and loading was stopped.

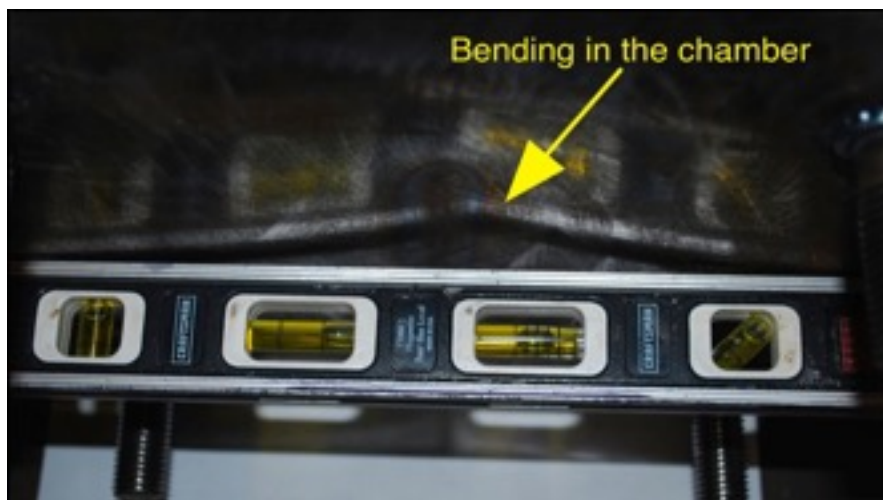
**Figure 9 Bending on the Back Plate in the Chamber**

This connection was able to resist 70.0 kips of gravity load – refer to Table 6. This load corresponds to a safety factor of 2.33. The seat had been welded to the back plate of the chamber. The back plate of the chamber experienced large deformations as the seat rotated. The failure mode was very ductile. Excessive bending of the back plate is evident from Figure 9.
